Sweeneys Lagoon Monitoring Update

April 2007

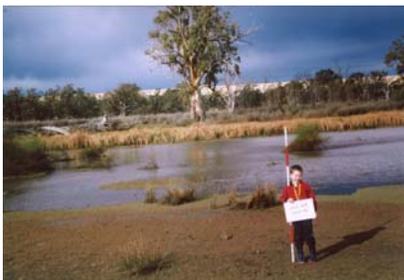
Photopoint (direction 01) established 28th July 2006. Wetland still has water due to high river levels and pumping project. Lots of floating azolla on edge of water, red gum in background looking healthy. Good work Ben!

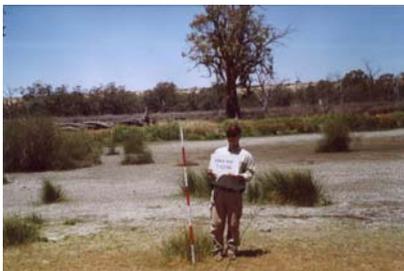
Photopoint 01- 7th December 2006.

Clumps of juncus have increased just behind Tumi. Water has receded to a small puddle in centre of wetland (out of view of photo). Rats-tail couch (native grass) starting to spread, but wetland bed is still relatively bare.

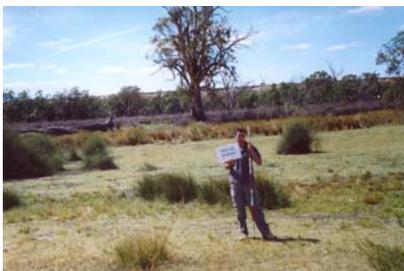
Photopoint 01- 5th March 2007.

Red gum in background has significantly less foliage. Lignum still looking healthy, rats-tail couch and chenopods establishing and covering wetland bed. Typha in background looking stressed from lack of water.

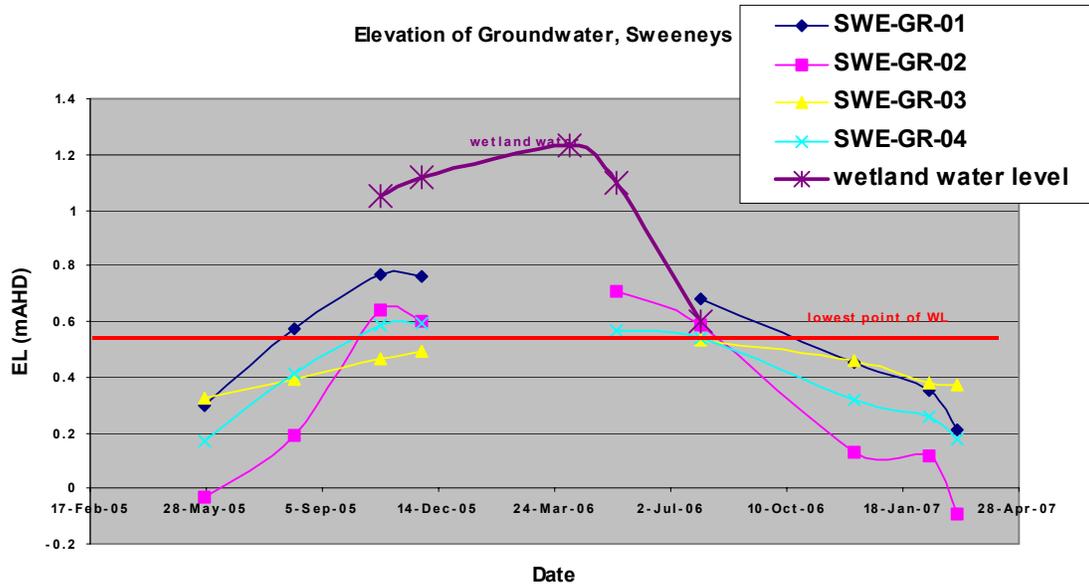
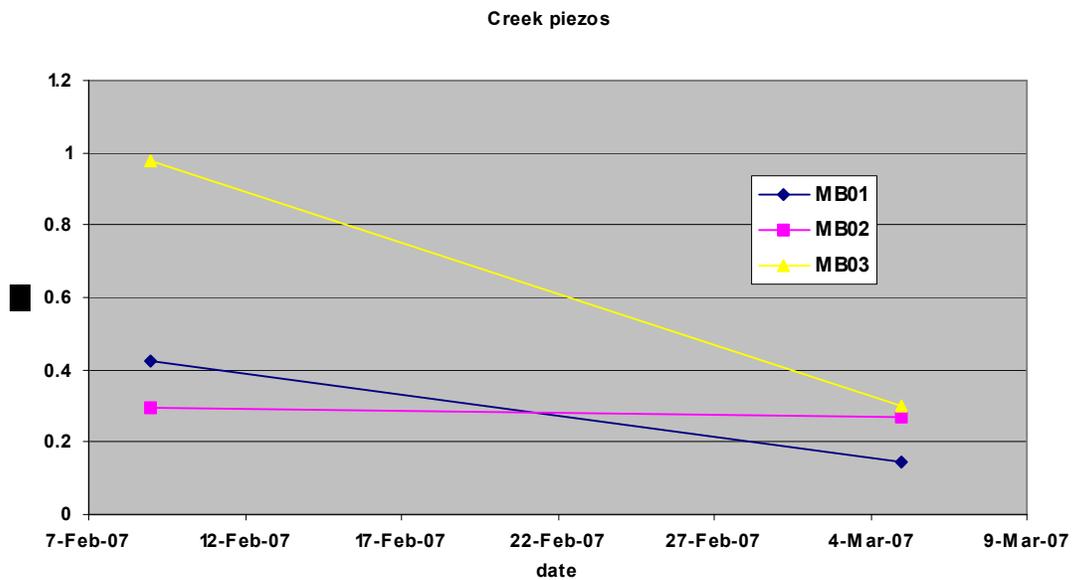
Groundwater levels around the wetland have dropped rapidly in conjunction with the fall in surface water levels and the drop in river level. Results show that groundwater flow is likely in a south-westerly direction, as the highest elevations are found in the north-east section of the floodplain. Groundwater levels have also fallen in the temporary creek beds- most likely a result of river levels also dropping. All groundwater levels are much lower than the elevation of the wetland bed, indicating that it is unlikely that groundwater is entering the wetland basin.

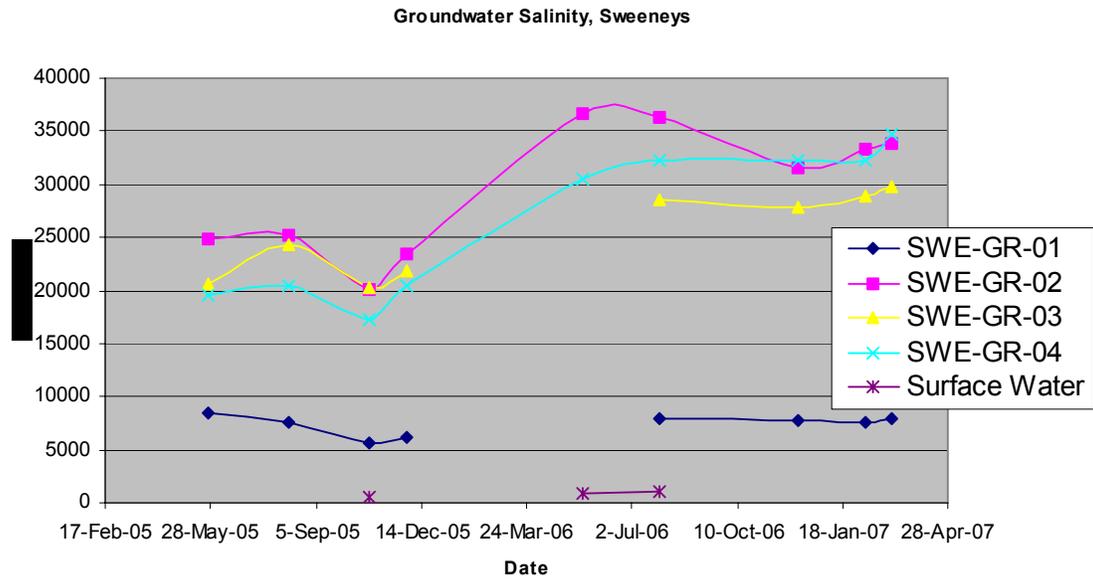
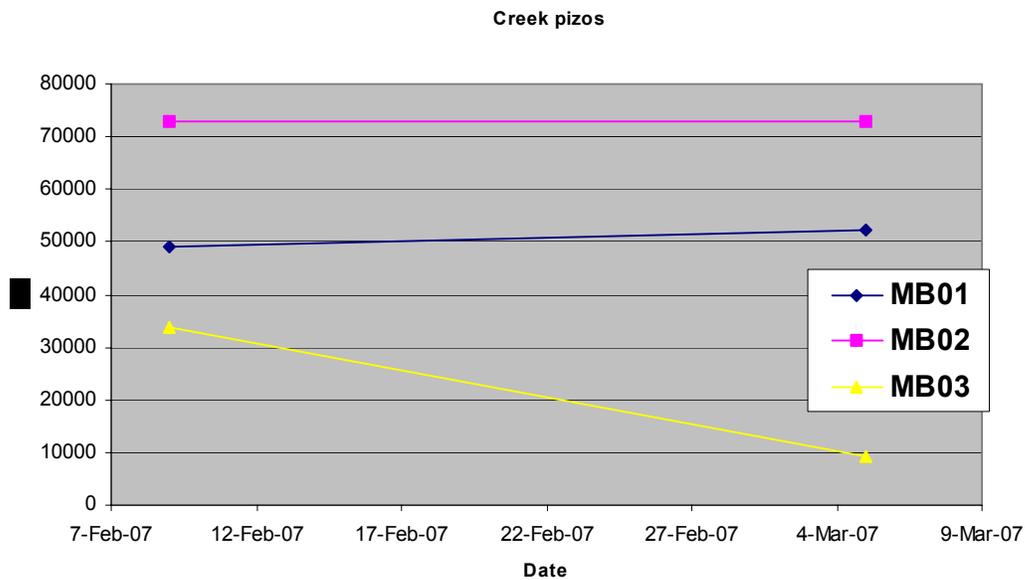
Groundwater salinity levels have increased slightly over the last few months, with the highest salinity recorded in piezo MB02, situated in the creek, at 73,000EC (about 1.5 x seawater). The freshest salinity was recorded at piezo SWE-GR01 (located next to the wetland), which has remained fairly constant. The biggest drop in salinity was seen in piezo MB03, the most northerly of the creek piezos.

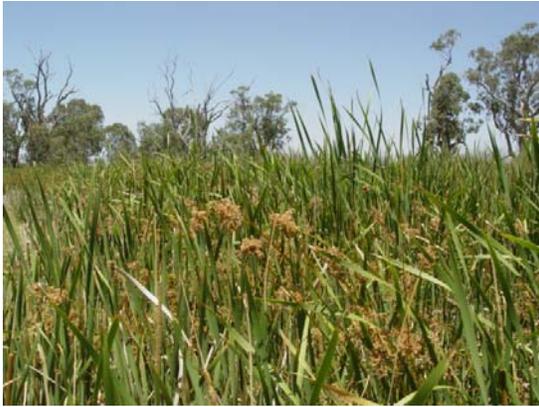
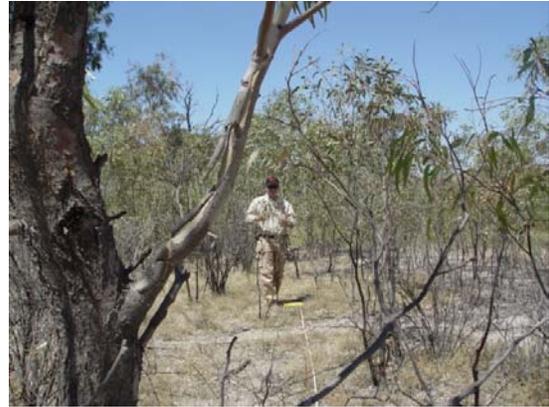
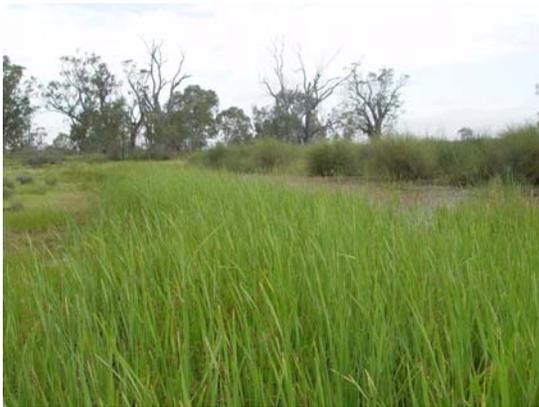
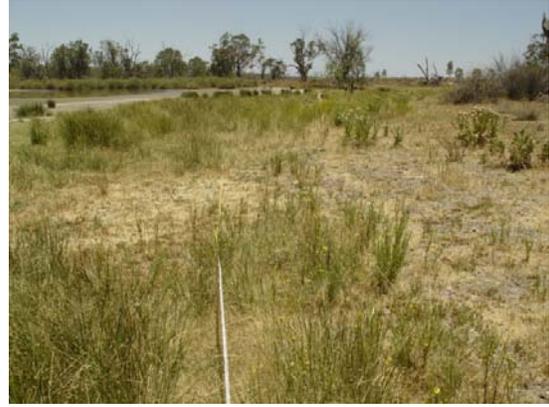
Permanent vegetation monitoring quadrats have been set up at two sites at the wetland based on elevation gradients. Data has been collected for two consecutive years in summer. A total of 33 plant species have been surveyed in the small area covering the quadrats.

Some of the different vegetation communities surveyed
