For those new to the Sugarshack wetland monitoring program, Welcome! Of the 8 water bodies within the Sugarshack floodplain, one lagoon is managed and is part of the community wetland-monitoring program run by the Mid Murray Local Action Planning (MidLAP) and SA Murray Darling Basin Natural Resources Management Board (SAMDBNRM) with the help from its landholders, the Mannum Aboriginal Community Association Incorporated (MACI). The information below is a brief look at what has happened in the wetland over 2008 and some goals for the upcoming year.

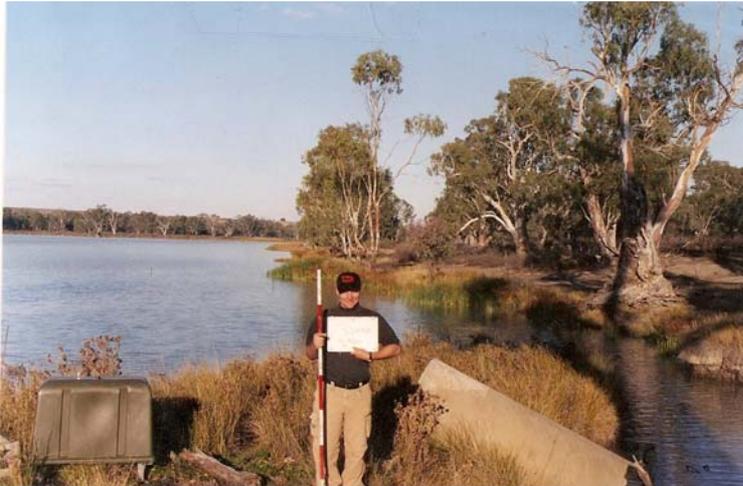
Plate 1; Photo point site 3, June 2006

- Normal pool level (0.7mAHD)
- Fringing vegetation healthy and flowering.
- Some Scotch Thistle present
- Proposed site of flow control structure

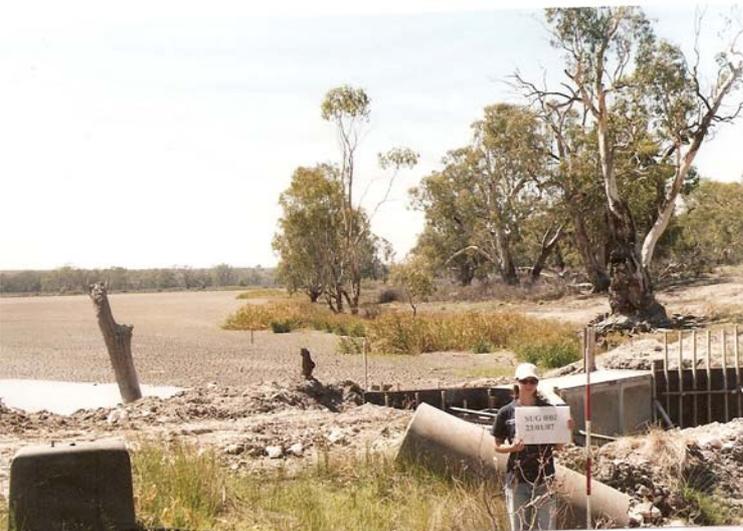
Plate 2; Photo point site 3, January 2007

- Wetland bed dry and firm (some rainwater pooling)
- Fringing vegetation still healthy
- Some emergent herbs on cracking wetland bed
- Flow control structure ½ complete

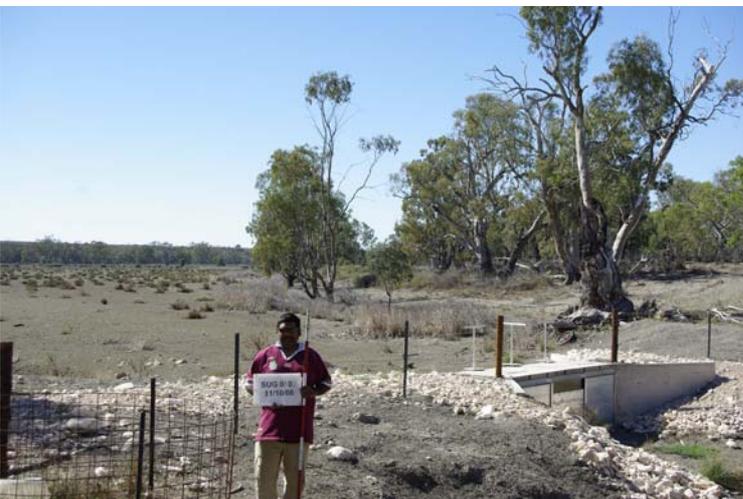
Plate 3; Photo point site 3, October 2008

- Wetland bed very dry and broken down into crumbs and fine dust due to stock access and exposure
- No new shoots from fringing vegetation
- Structure complete and fitted with carp screens

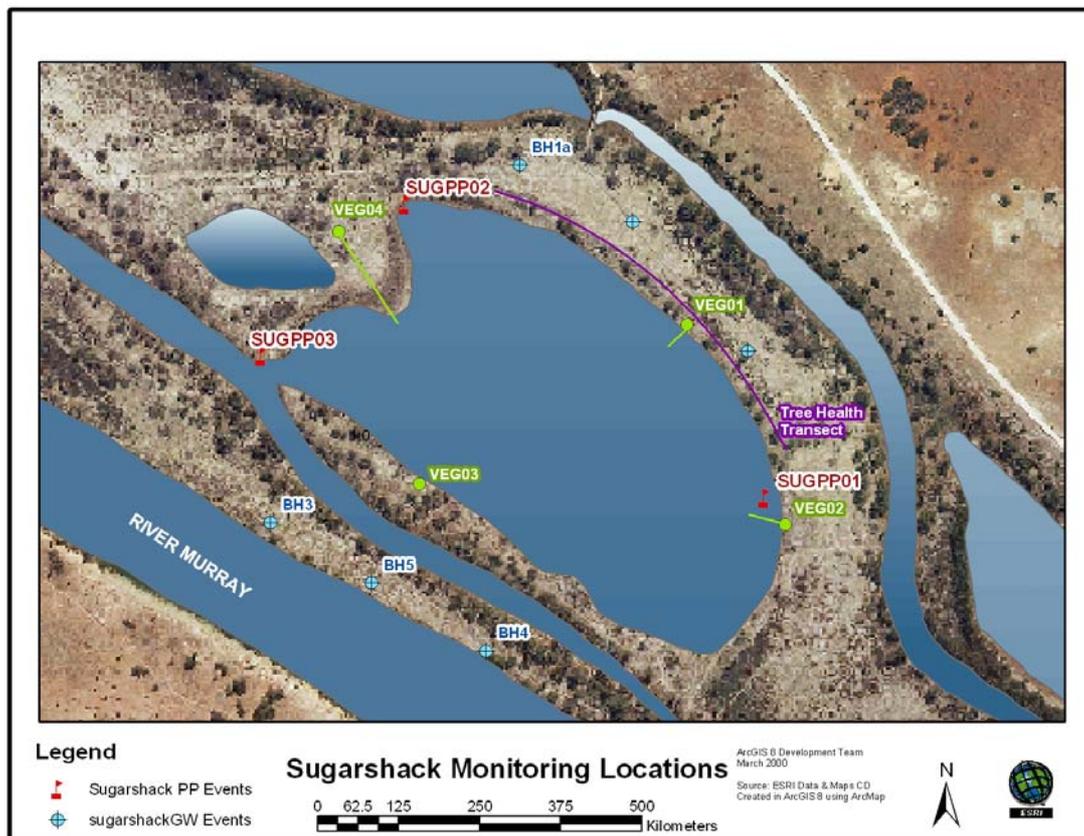
Figure 2; monitoring locations at Sugarshack Wetland

Throughout 2009, groundwater, tree health, frogs and vegetation have been monitored in set locations around the wetland (See figure 2 for monitoring locations). When water levels return, fish and water quality will also be included. 2008 monitoring was undertaken during March, June and October with the help of Sam Stewart Aimee Linke and Michele Gollan.

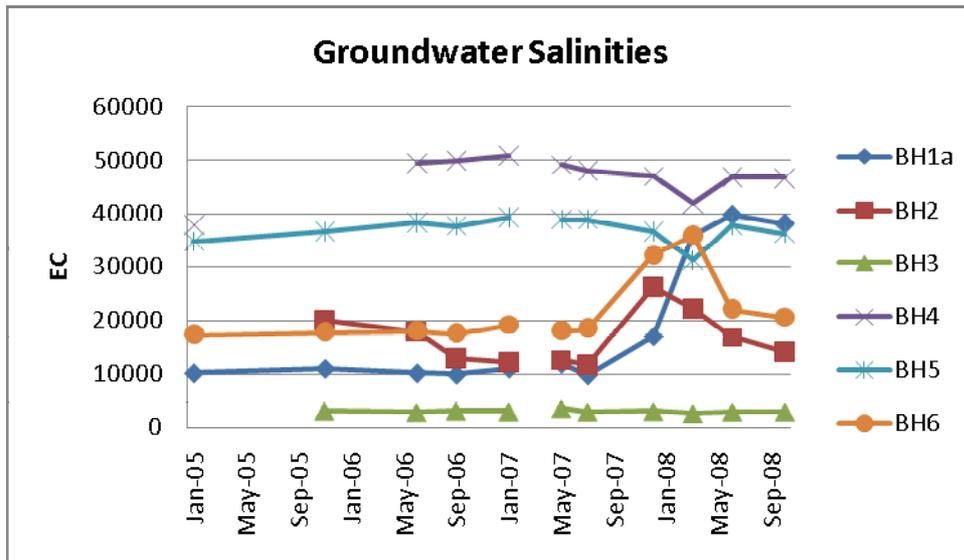
Figure 3; groundwater salinities

Figures 3 and 4 represent the levels and salinity of the groundwater, sampled from 6 permanently located piezometers around the wetland. The groundwater salinities dramatically increased during summer 06/07 when the wetland was drying and continued to increase into summer 2008. These levels have since lowered significantly in piezometers BH2 and BH6. These piezometers are located closest to the cliff line and more readily intercept groundwater from the highland. The drying on the creek and wetland to the north of the managed lagoon would also have influenced the levels and salinity at these piezometers.

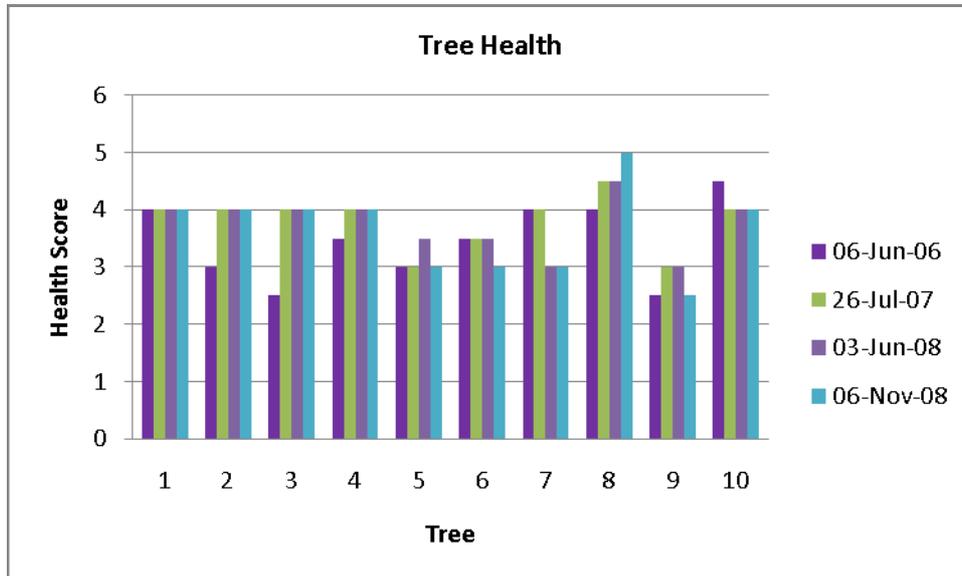
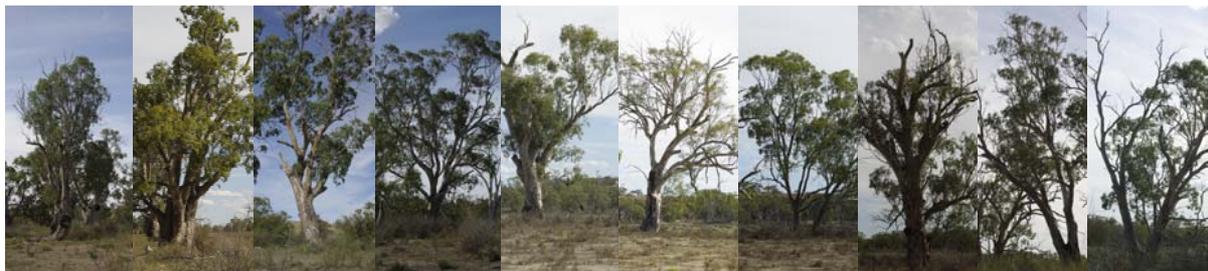
Figure 5; Tree health monitoring 2006-2008

Ten trees are monitored within a transect on the northern side of the wetland. All trees within the transect are mature River Red Gums (*Eucalyptus Camaldulensis*) of which are photographed and given a health score. This assesses original canopy cover, dead branches/branchlets and epicormic growth. Figure 5 represents the changes in tree health within the transect since June 2006. There have been mixed responses from the changes in water level. There have been improvements observed in tree 8 yet reductions in trees 6 and 7 since drying. Young trees outside of the transect are in excellent condition.

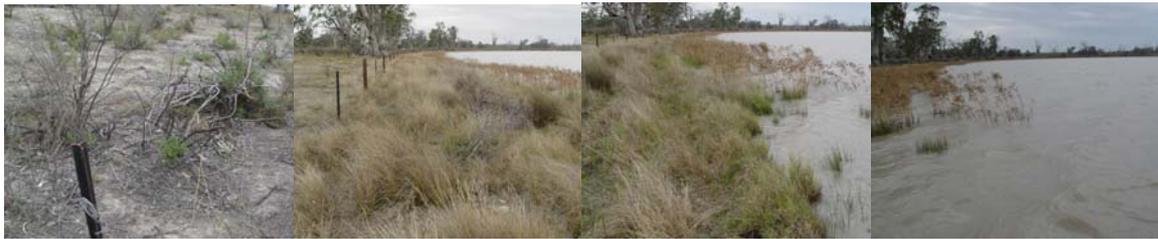
Plate 7: Vegetation Site 1, 2006

The wetland bed has become sparsely established with terrestrial species such as Bluebush (*Maireana* sp.), Umbrella Wattle (*Acacia ligulata*), Spiny Wattle (*Acacia nyssophylla*), Creeping Saltbush (*Atriplex semibaccata*) and Couch (*Paspalum* sp.). These species have replaced the aquatic species observed during the 2006 vegetation survey including Duckweed (*Azolla filiculoides*) and Red Water Milfoil (*Myriophyllum verrucosum*).
